Making Designing for River Water Quality an Easier Option

Presented at UGRA / Kerr County Extension Seminar on September 12, 2019

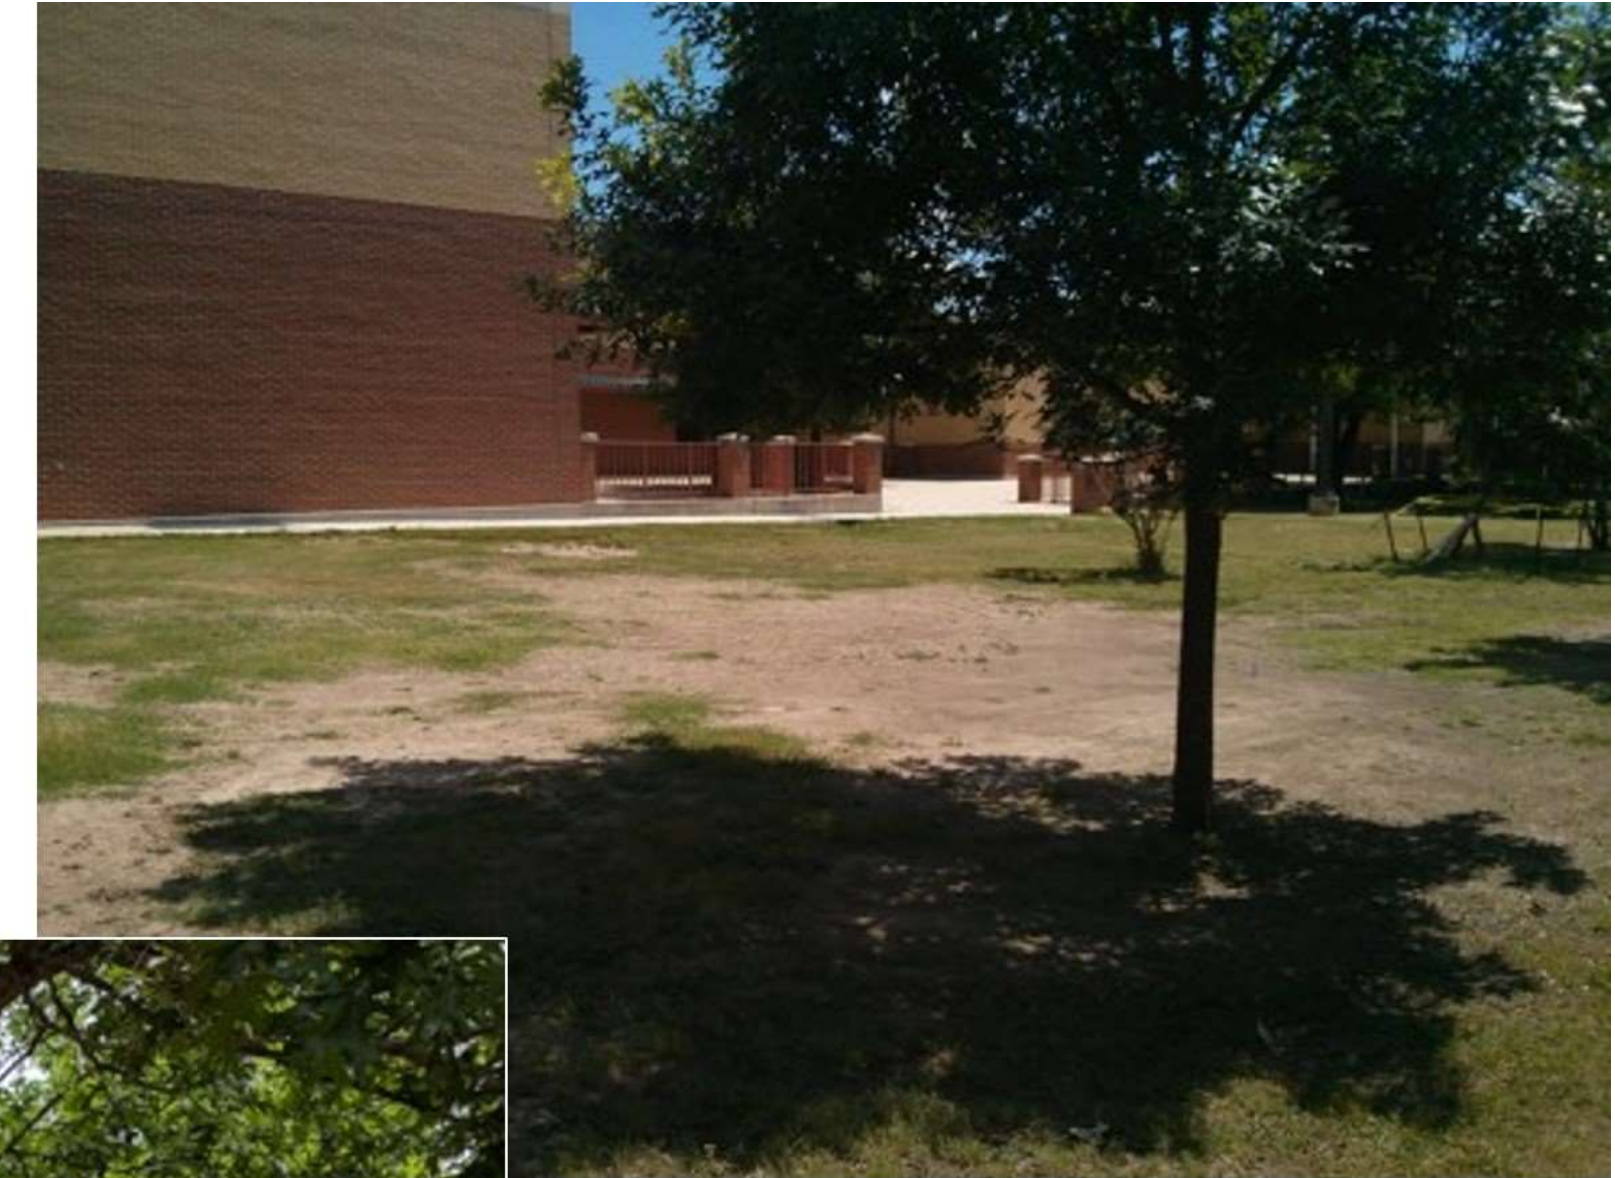
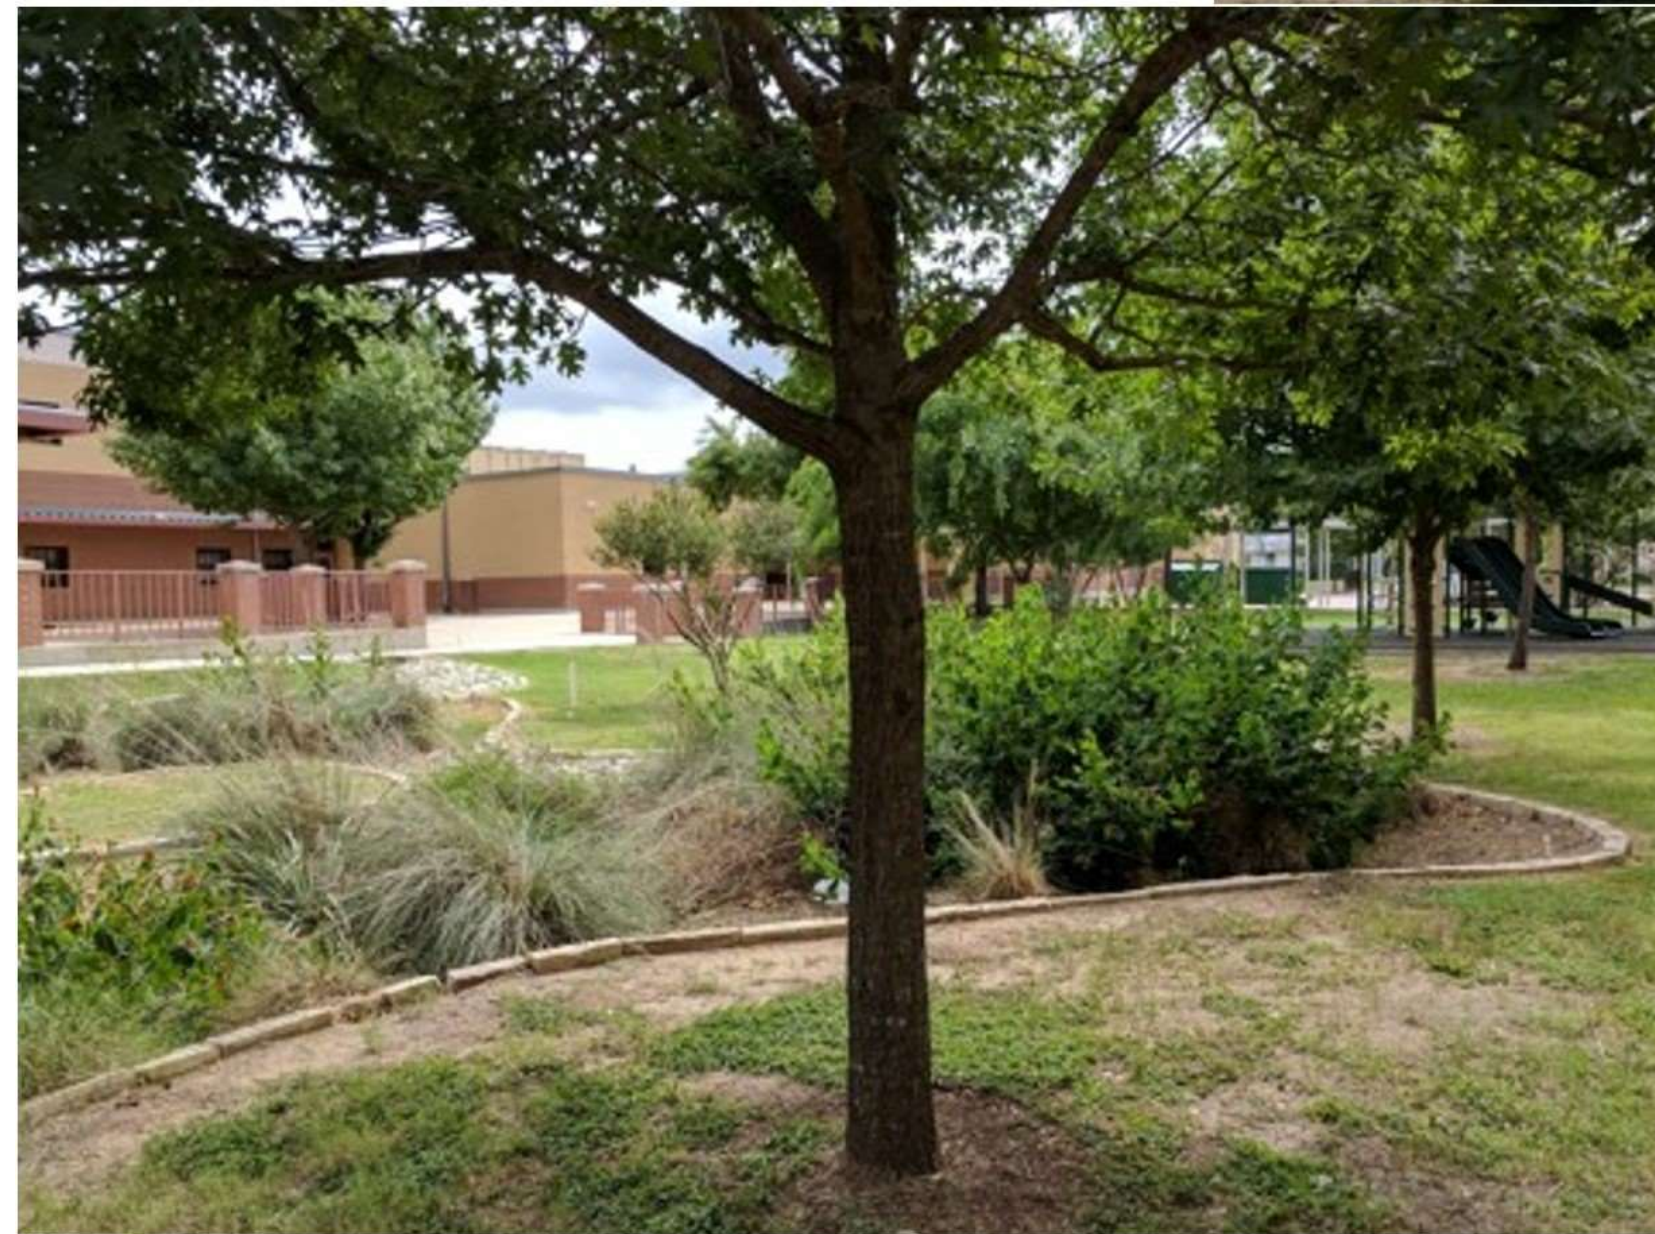
Before LID

After LID

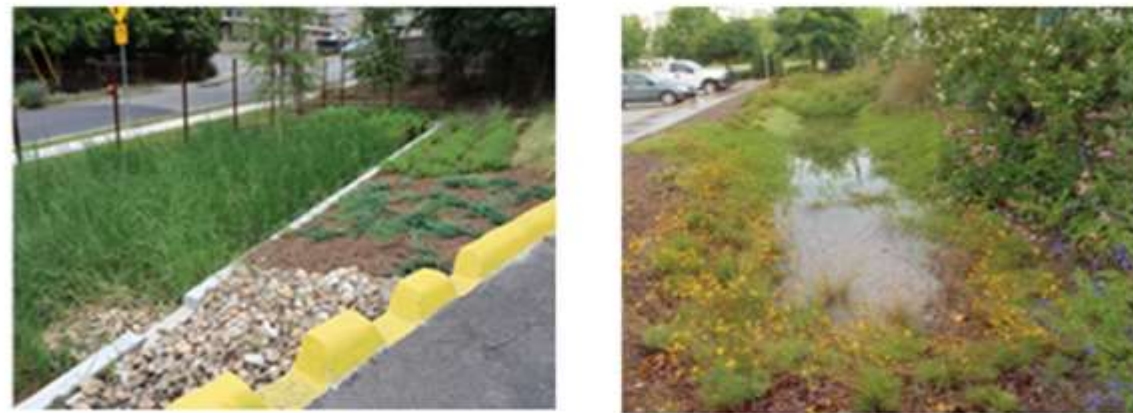
Bioretention areas are landscaped shallow depressions that capture and temporarily store stormwater runoff which is filtered through the soil media to remove pollutants. Bioretention areas usually consist of an inlet, a ponding area, mulch layer, planting soil media, native plants, an overflow device, or underdrain.

Figure 1. Examples of bioretention

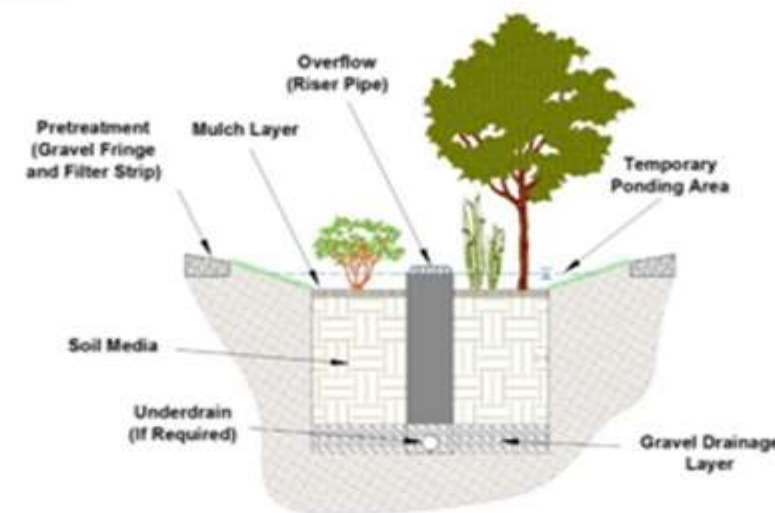
Figure 2. Schematic of bioretention highlighting the ponding area and overflow area. (Not all systems have the riser pipe.)

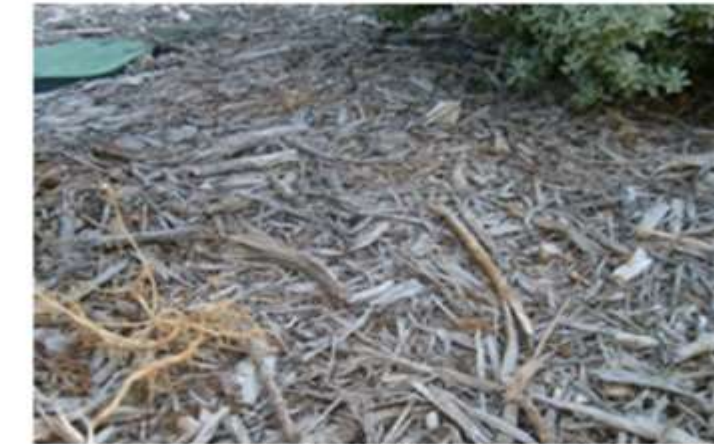
- Mulch:** Maintain a 2 to 3-inch depth of dimensional chipped hardwood mulch, or triple-shredded hardwood mulch. Periodically, the mulch layer should be broken up and raked out, as over time it tends to solidify into a solid mass with reduced capacity for infiltration. Mulch should be completely replaced every 2 to 5 years.

Figure 3. Maintain 2 to 3 inches of mulch

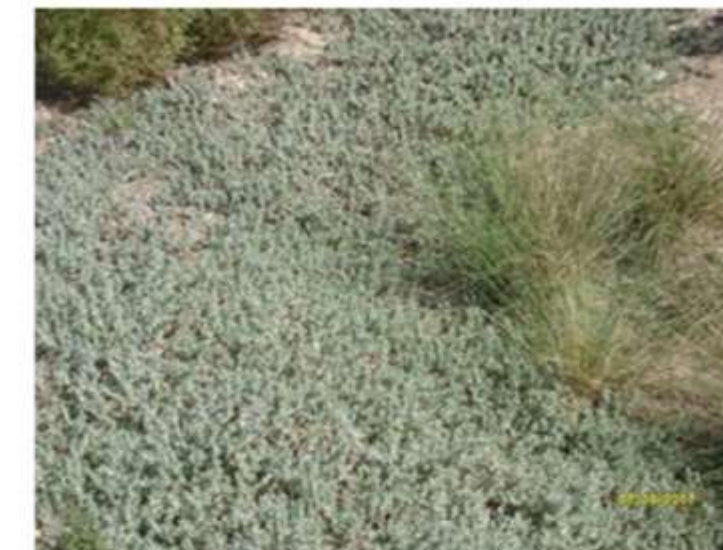
Figure 4. Example of vegetation growth that eliminates the need to weed. Woolly Star, shown, and Gulf Muhly are well suited to bioretention.

- Plant Material and Weeding:** Replace all dead plants, and if specific plants have a high mortality rate, assess the cause. If necessary, replace with more appropriate native species. Periodic weeding is necessary until plants are established. The weeding schedule can become less frequent if the appropriate plant species and planting density have been used and, as a result, undesirable plants are excluded. Prune as necessary to maintain the desired aesthetic.

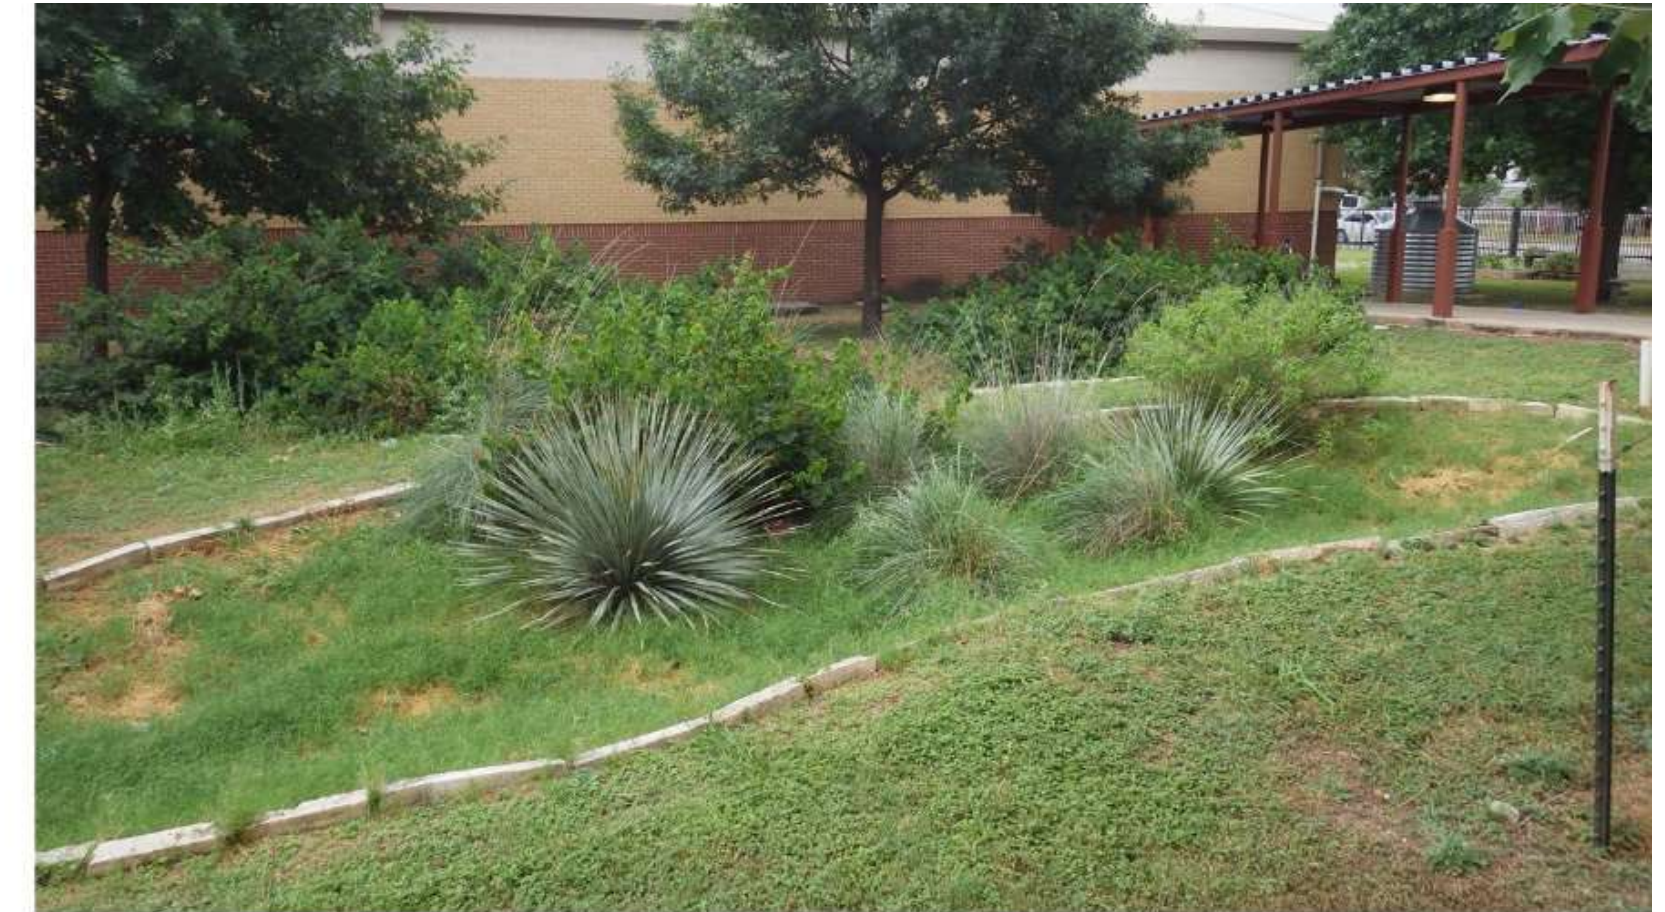
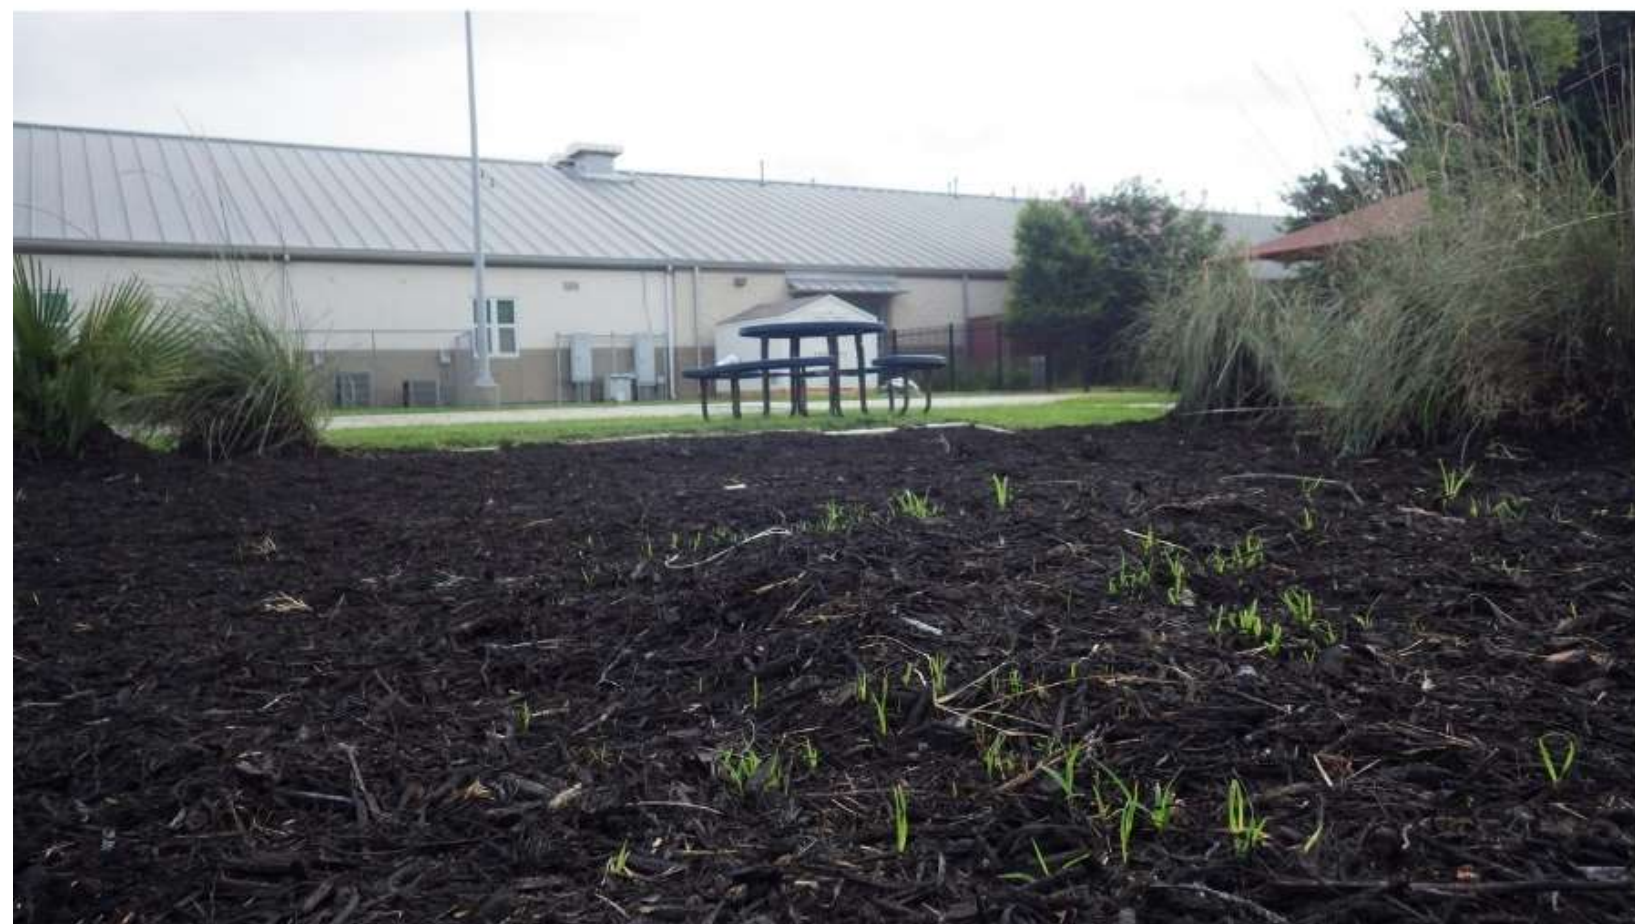
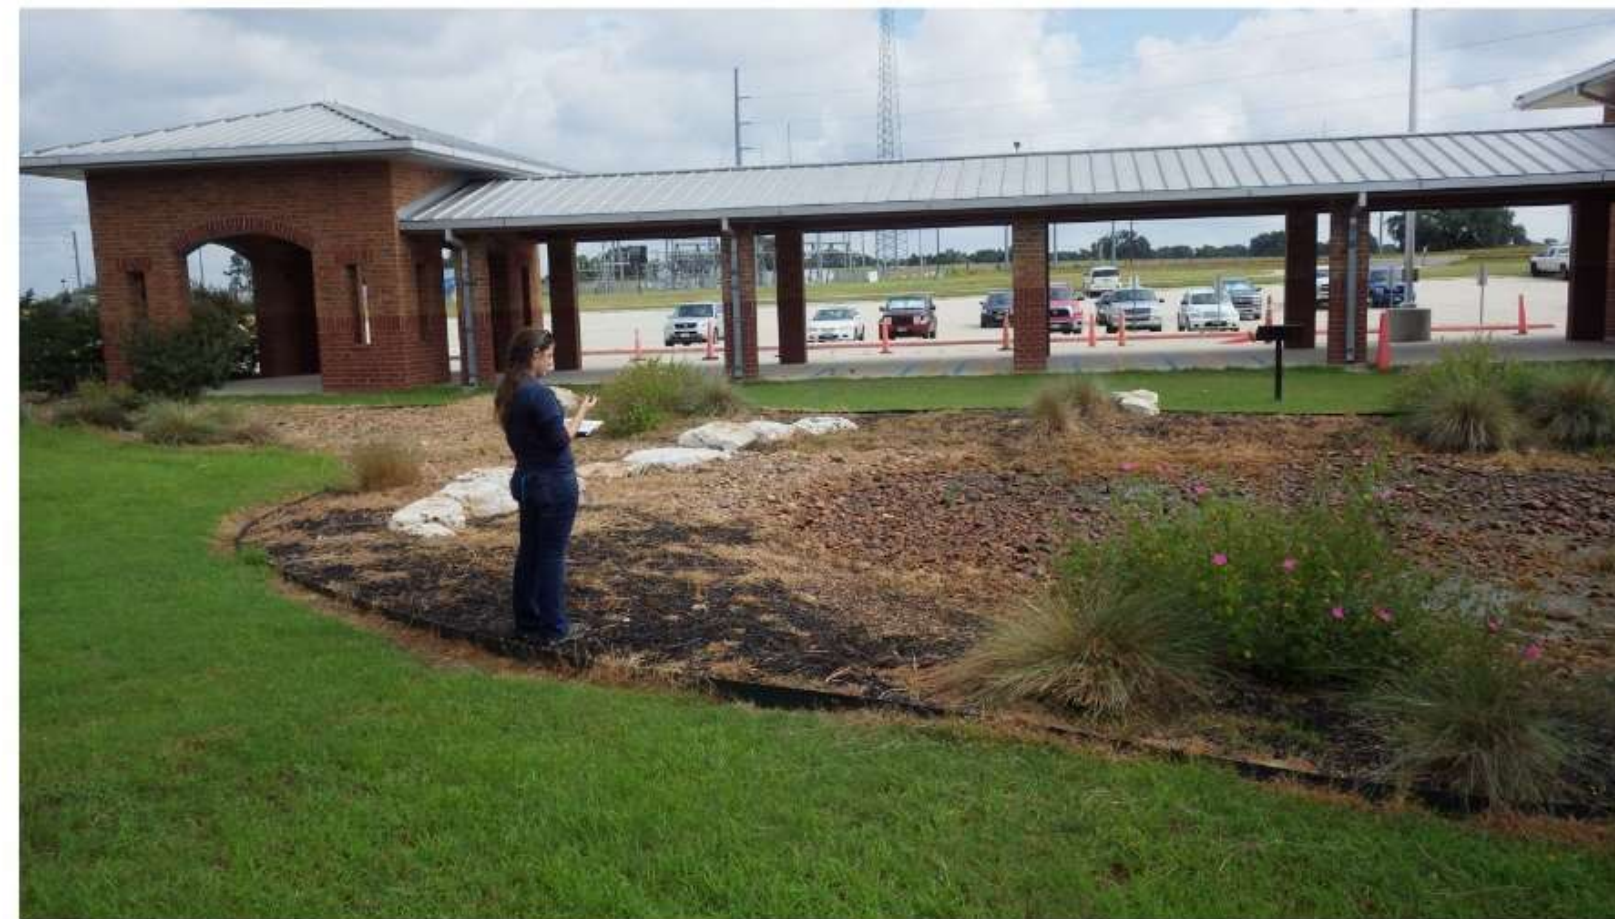
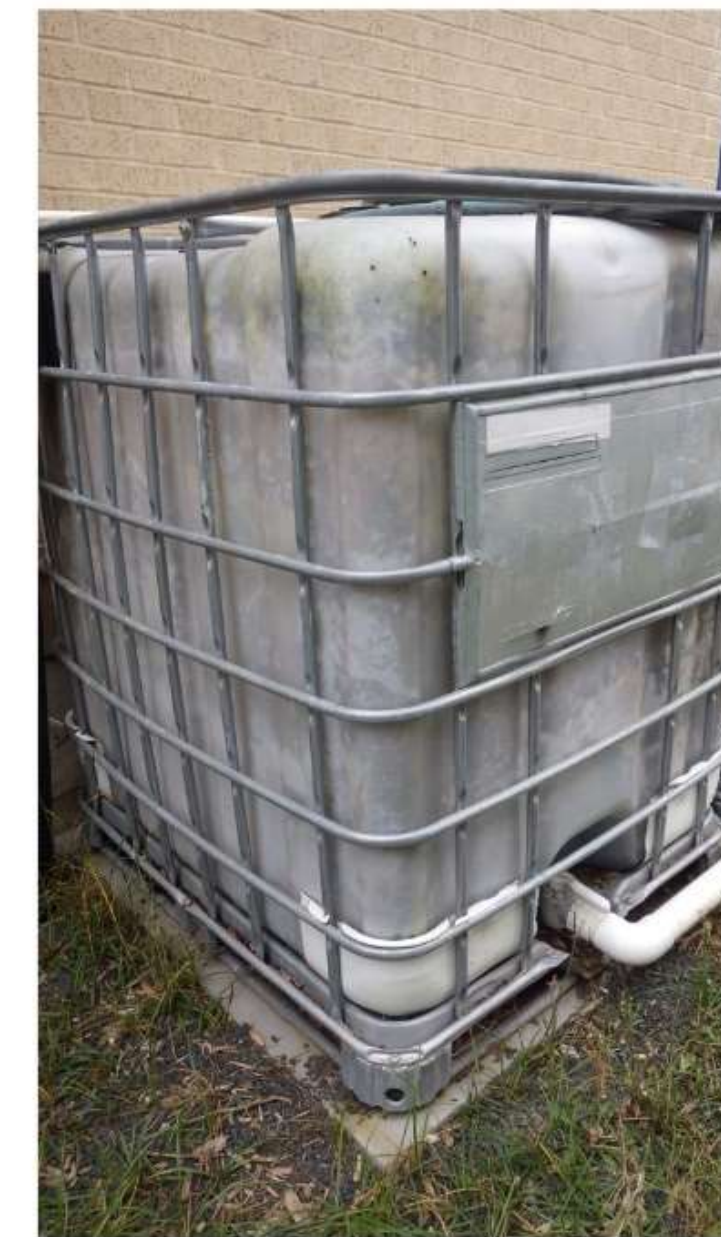
Inspections Findings

- Weeding and grass removal
- Native plant understanding
- Water volume / infiltration
- Cistern maintenance

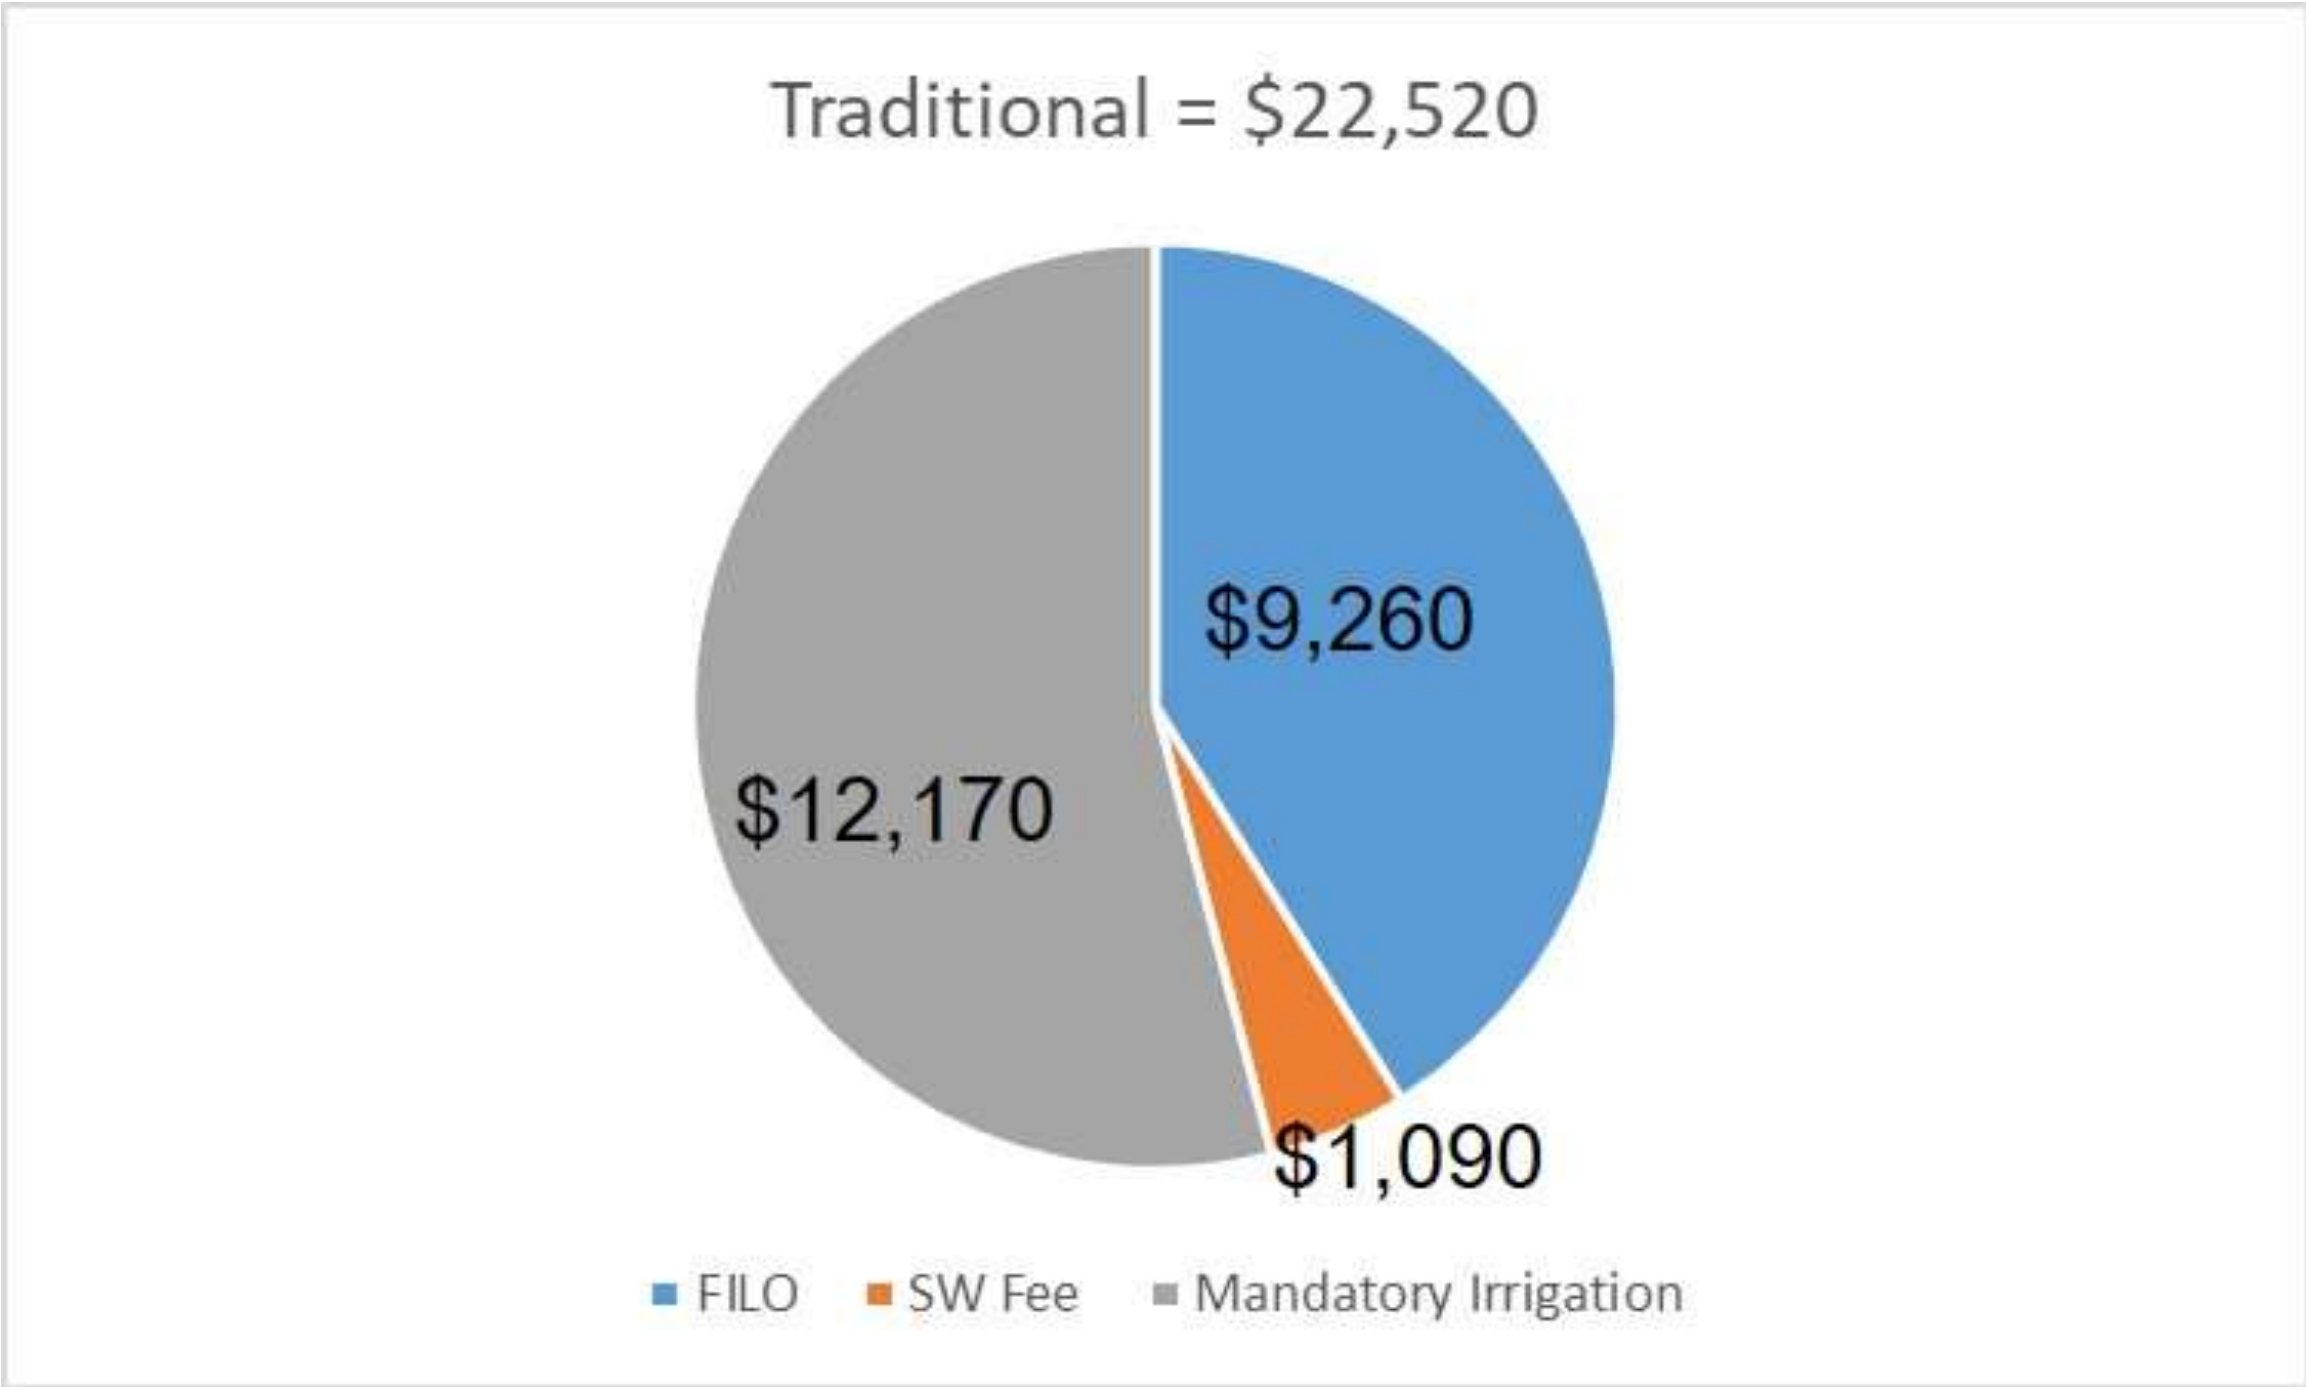
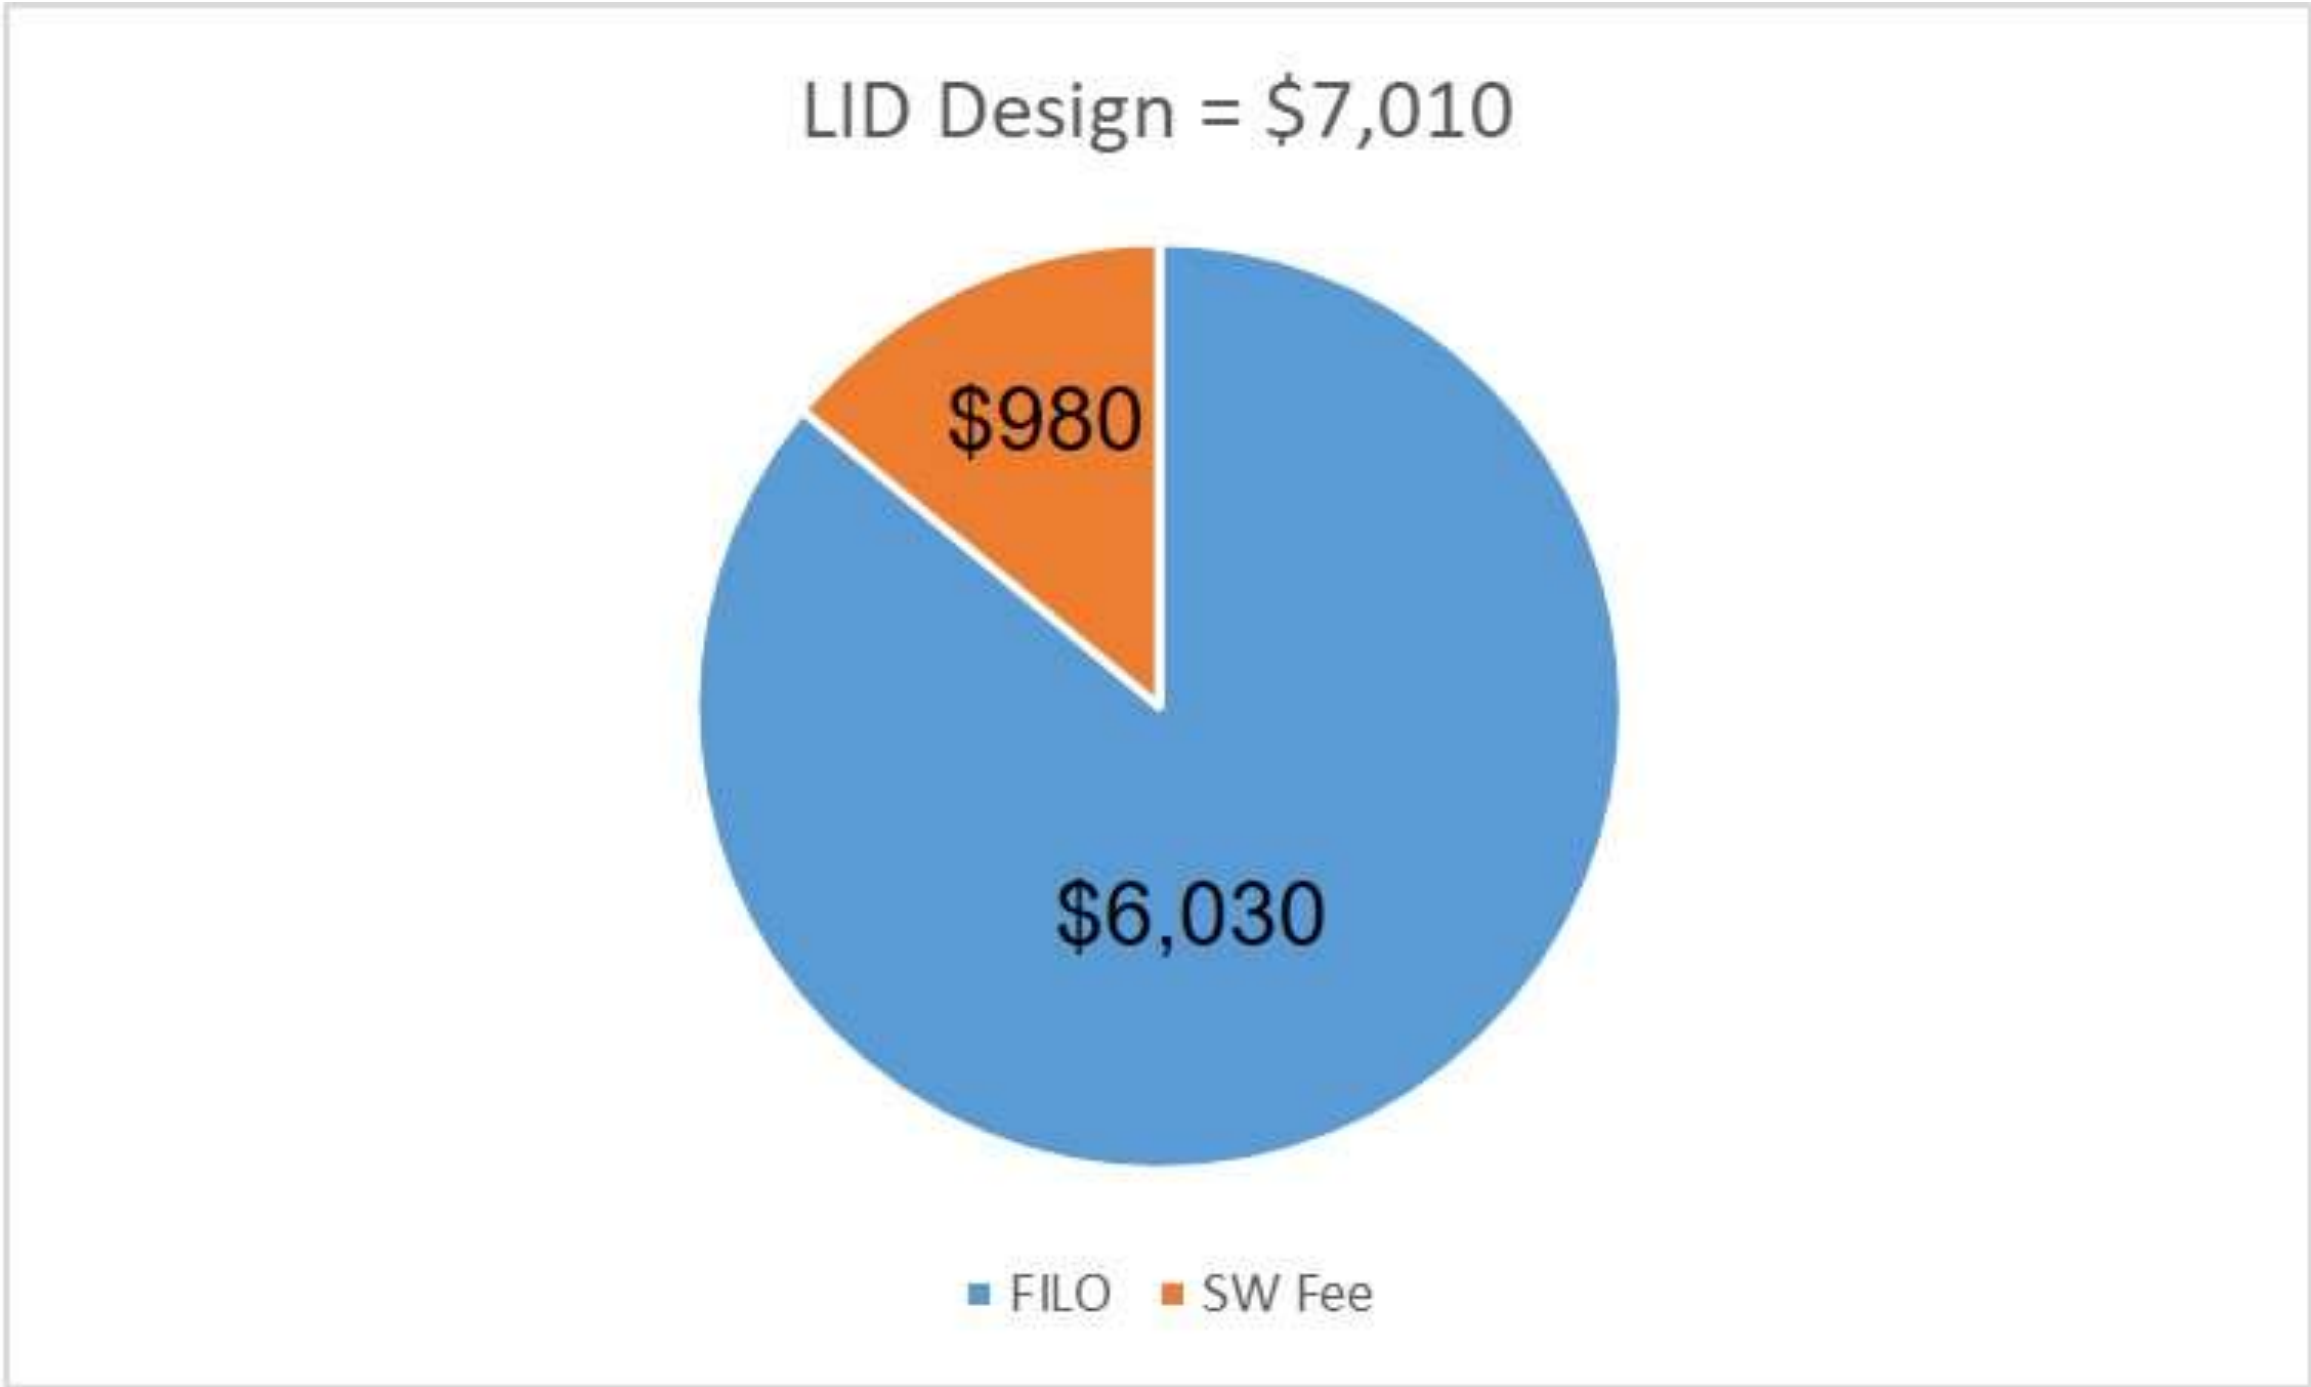
Traditional vs. LID Comparison

40,000 SF traditional parking lot design compared to LID design with bioswale:
\$15,510 savings with LID.
